**A review into the causes of passenger disruption affecting King's Cross and  
Paddington station services on 27 December 2014**

**Dr Francis Paonessa**  
**Managing Director Infrastructure Projects, Network Rail**

**12 January 2015**

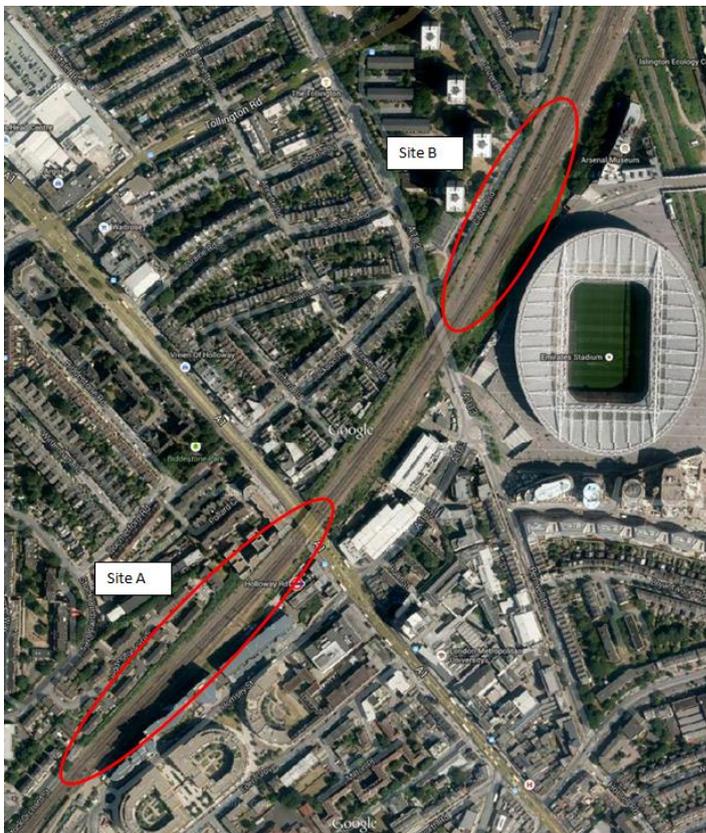
Figure 1. Site A and Site B

Holloway Junction is approximately 1½ miles north of King's Cross Station and is part of the East Coast Mainline (*fig 1*). There are four railway lines at Holloway interconnected by four junctions to allow trains to pass from one line to another. The junctions are approaching the end of their service life as is the 300mm of ballast (stone) which sits beneath the junctions and which provides the foundations for the railway. If the junctions and ballast were not renewed then the likelihood of points and signalling failures would increase, leading to significant disruption to train services and the passenger ride quality would deteriorate.

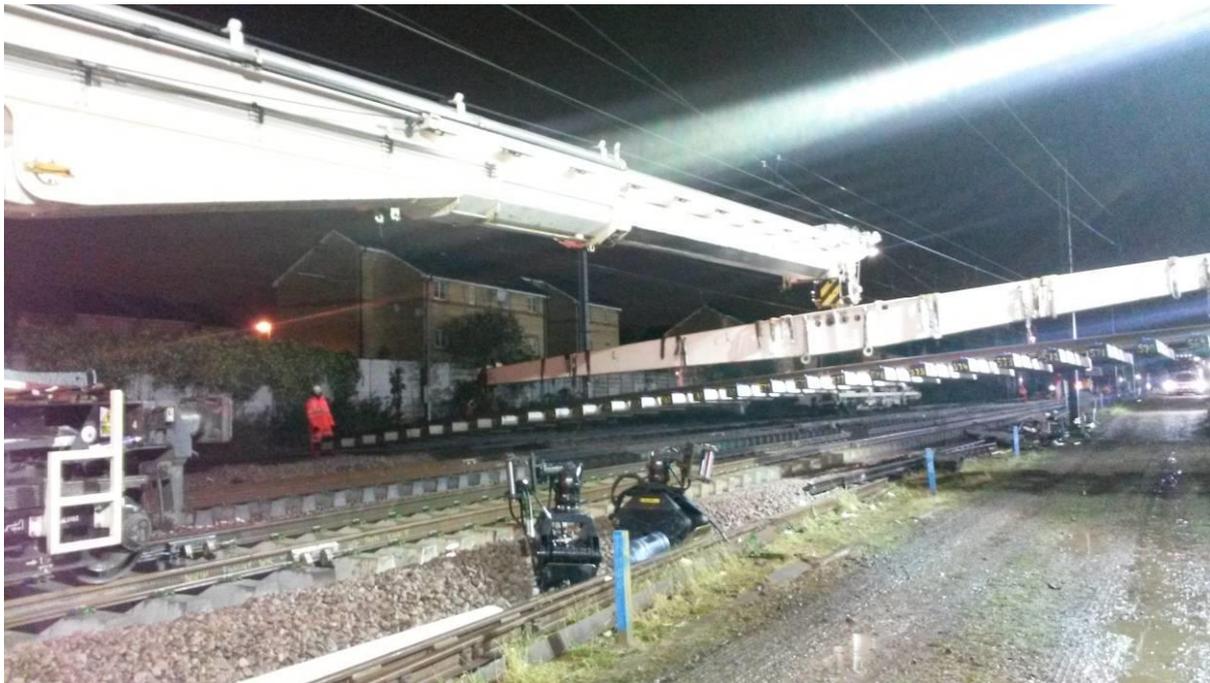
Figure 3. Above: Track panel being installed at Holloway Junction.

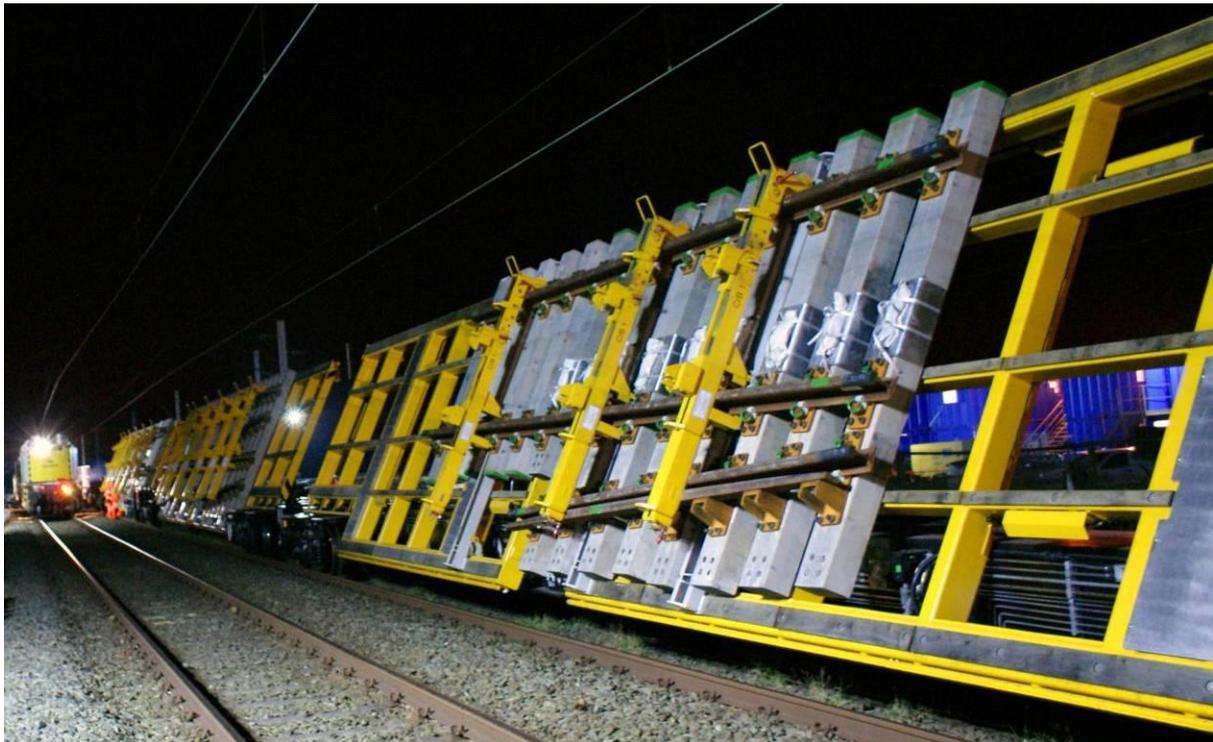
Around 6,000 tonnes of new ballast then had to be installed and levelled and eighty-two pre-assembled track panels (*fig 4*) laid on top like jigsaw pieces. Some 180 welds were then required to join everything together followed by alignment checks on the 25,000 volt overhead cables. In total about 8,000 hours of work was undertaken by the "Northern S&C Alliance". S&C stands for switches and crossings, commonly known as points and crossings. The Northern S&C Alliance is one of two contractual alliances recently set up by Network Rail and comprises Network Rail and Amey Rail, the contractual obligations of Amey Rail being discharged by the AmeySersa Joint Venture.

*Figure 4. S&C panels ready to be lowered.*

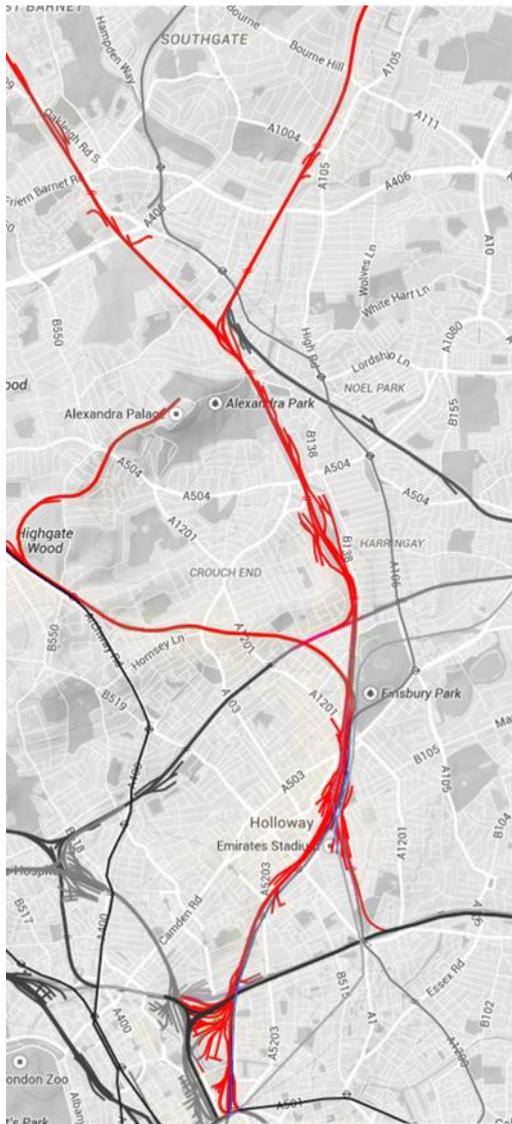
Figure 5.  
Extent of possession

In parallel, there were a significant number of other engineering works being undertaken between King’s Cross and Peterborough which closed the East Coast Mainline in multiple locations. As a result, it was not possible to bring the engineering trains straight to site from their depots. In total, 14 engineering trains were required to support the project at Holloway and they had to be delivered to site ahead of the work and parked up. The large number and size of these engineering trains made the total worksite (*fig 5*) around 9 miles long in order to accommodate them safely and to allow them the space to move in and out of the construction area in a carefully choreographed sequence.

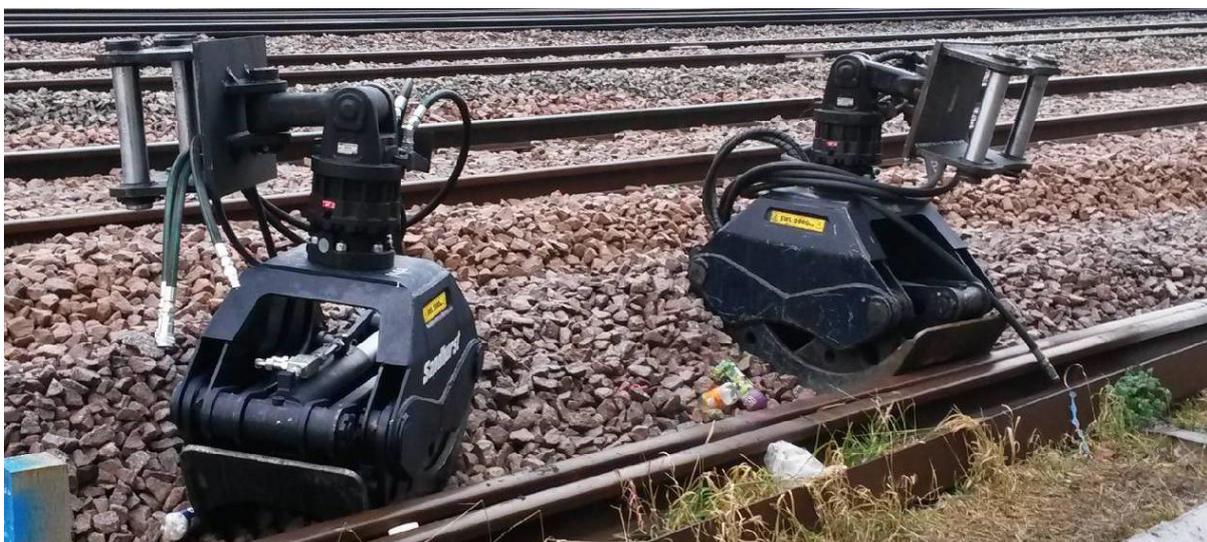
Figure 6. Log grabs

Equipment is key and there was contingency with spare track burners (used to cut the track into pieces), spare log grabs (used to remove the scrap track and rail sleepers) (*fig 6*), as well as in other hand and powered tools.

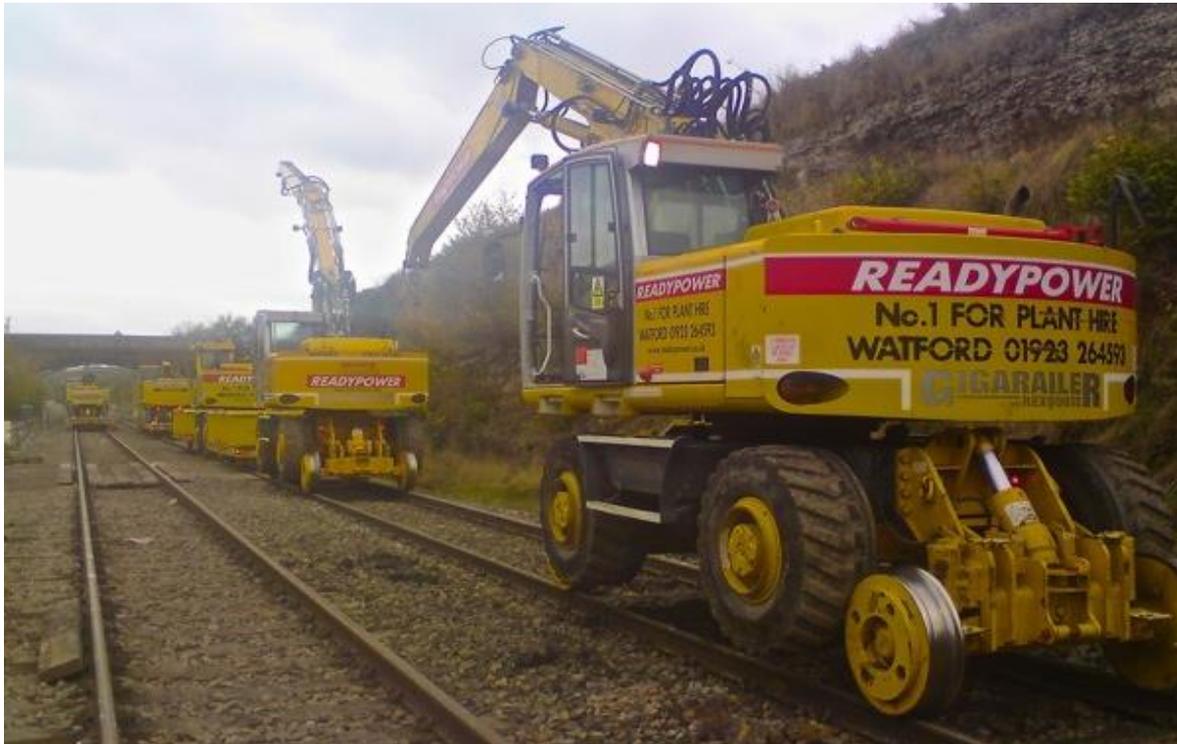
Figure 7. Typical RRV.

The Road Rail Vehicles (RRVs) (fig 7) were sourced and provided by an approved supplier to ensure that the risk of mechanical failure was minimised. The supplier of the plant and equipment also provided eight new log grabs to reduce the risk of key plant failures. Seven log grabs were needed to deliver the plan and a spare was provided as a contingency. The plant supplier also provided an on-site fitter so that any equipment problems could be fixed quickly.

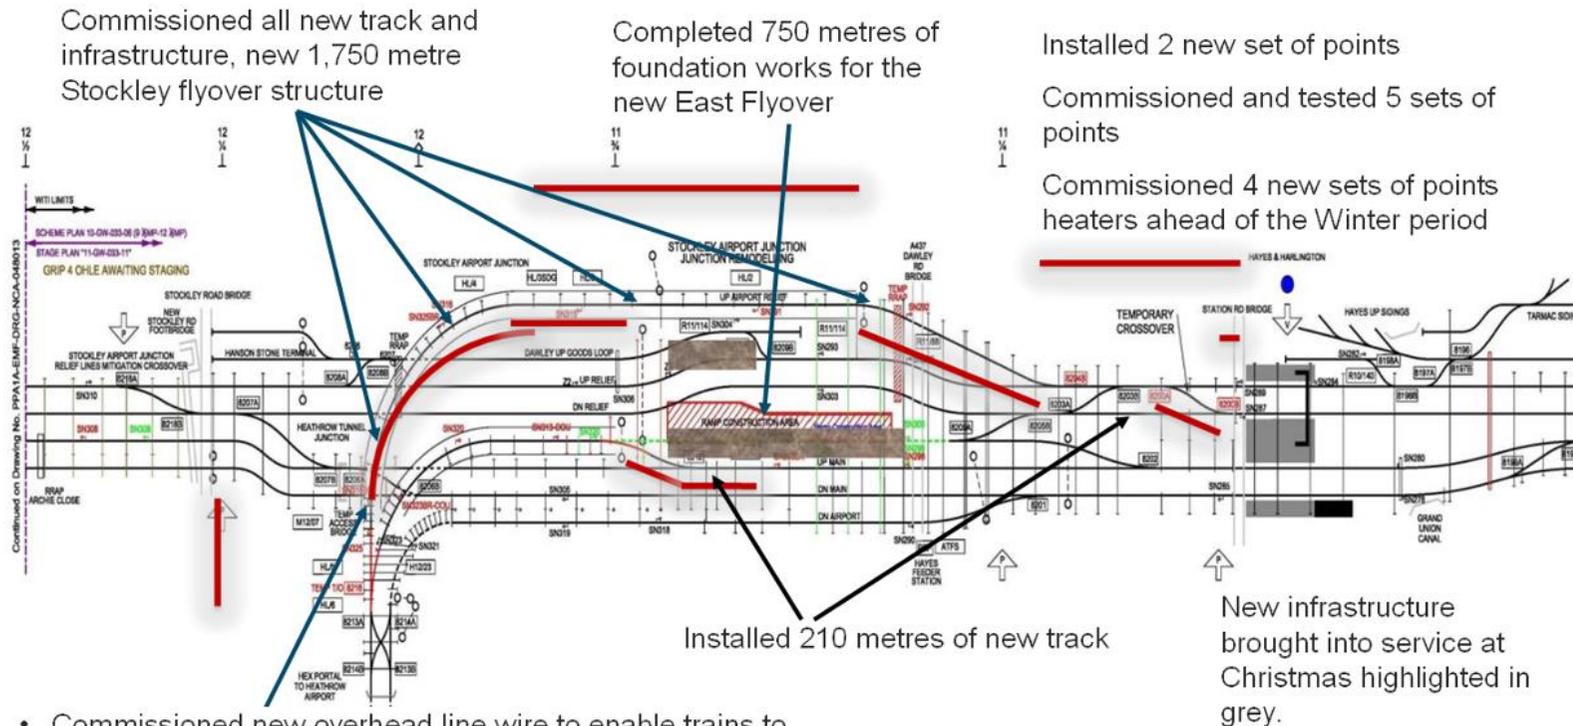
**Figure 12. Stockley Airport Junction - Christmas 2014 Works**

Opened New 1,750m flyover and junction to enhance connections to Heathrow Airport from the Great Western main line

Commissioned all new track and infrastructure, new 1,750 metre Stockley flyover structure

Completed 750 metres of foundation works for the new East Flyover

Figure 10 shows the geography of the worksites. Figures 11 and 12 describe the work undertaken at Old Oak Common and Stockley and Figure 13 is an aerial view of Stockley.

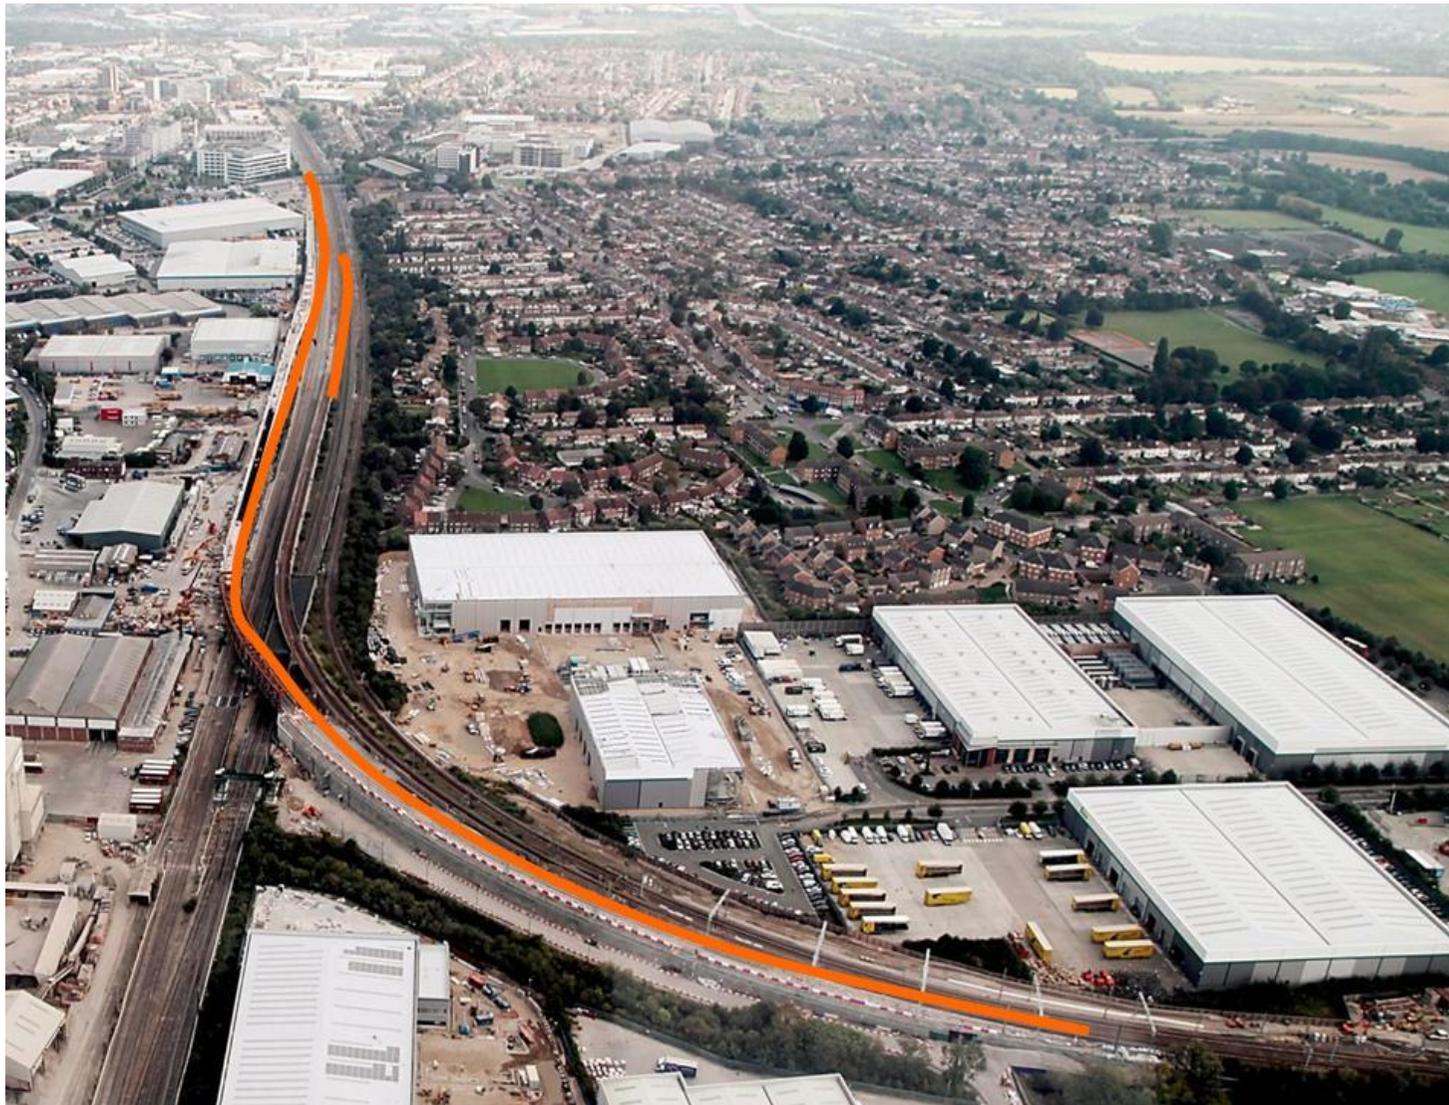
*Figure 13. Stockley Airport Junction - Christmas 2014 Works*

- Commissioned new overhead line wire to enable trains to run on new line
- Commissioned 14 new signals and signalling infrastructure for new Line
- Installed new overhead line equipments structures for new Line and removed redundant structures
- Removed 850 metres of old overhead line equipment
- Removed 610 metres of old track
- Removed 3 existing signals
